Project: Burj Khalifa
Document: Snagging report
Time Range: 2026-09-14 to 2026-09-20
Compiled by: SACO

Snagging Report 14/09/2026 to 20/09/2026

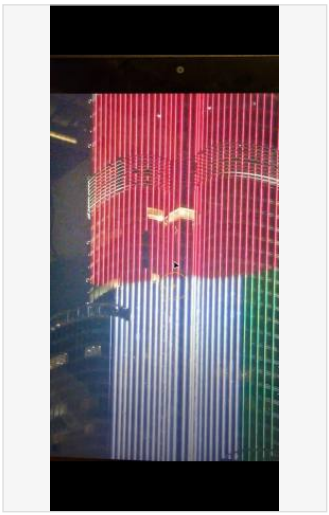
C19-49-46
Case #42203

Location	Error type	Fix types	Comments
C19-49-46	Black point	300mm VStick replacement (1)	
C07-105-103	Black point	500mm VStick replacement (1)	
C12-111-109	Black point	500mm VStick replacement (1)	
C25-49-46	Black point	500mm VStick replacement (1), Jumper replacement (1)

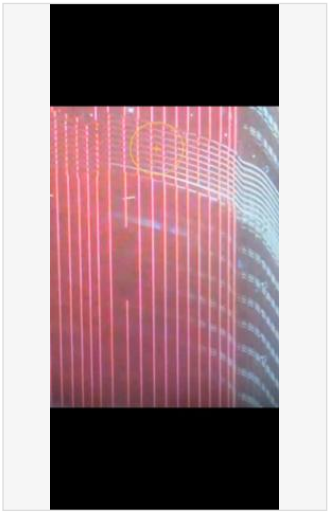
B16-9-8
Case #42207

Location	Error type	Fix types	Comments
B16-9-8	Black point	300mm VStick replacement (1), 500mm VStick replacement (1)	
B02-134-133	Black point	500mm VStick replacement (1)	
B15-58-55	Black point	300mm VStick replacement (1), 500mm VStick replacement (1)

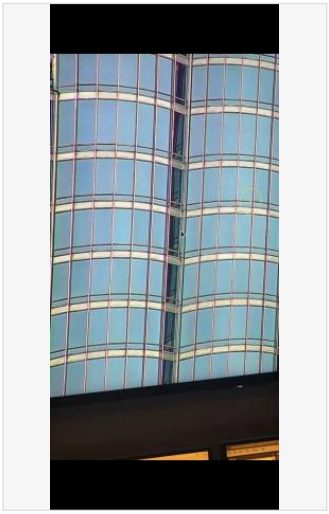
B27-25-23
Case #42212

Location	Error type	Fix types	Comments
C11-80-78	Black point	Jumper connection	
B27-25-23	Flickering	500mm VStick replacement (1)	
C03-31	Black point	300mm VStick replacement (1)

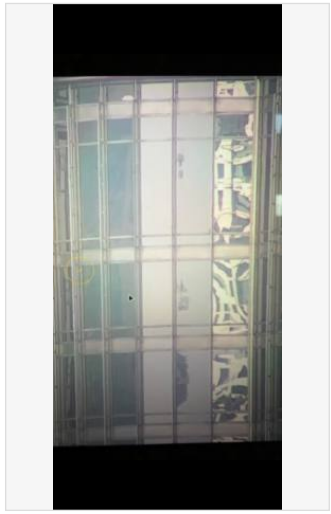
C10-62-59
Case #42215

Location	Error type	Fix types	Comments
B04-51-49	Black point	300mm VStick replacement (1)	
C10-62-59	Black point	300mm VStick replacement (1)	
CB01-78-74	Frozen	500mm VStick replacement (1)	
B14-16-14	Black point	500mm VStick replacement (1)	
C04-13-10	Black point	300mm VStick replacement (1), 500mm VStick replacement (2)

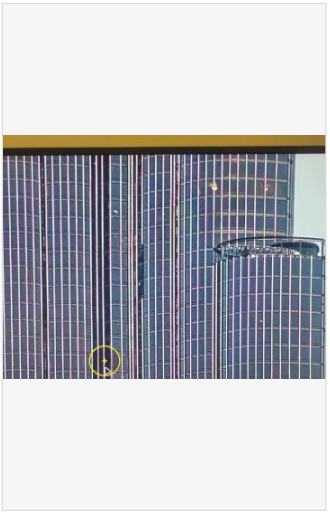
C23-60-57
Case #42219

Location	Error type	Fix types	Comments
C23-60-57	**Black point**	**300mm VStick replacement (1)**

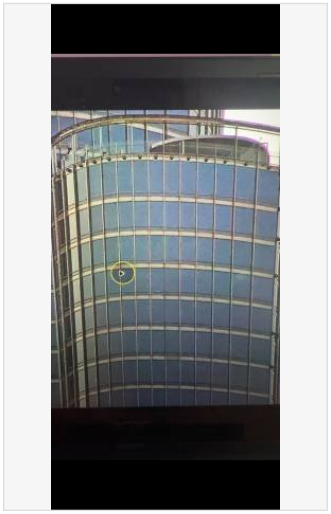
B06-54-52
Case #42222

Location	Error type	Fix types	Comments
C13-72-70	Black point	500mm VStick replacement (1)	
B19-9-8	Black point	300mm VStick replacement (1), 500mm VStick replacement (1)	
B06-54-52	Black point	300mm VStick replacement (1)	
B19-83-81	Black point	500mm VStick replacement (1)
